REHABILITATION OF ROADWAY EMBANKMENT

NATURE OF INTERVENTION

Modderfontein, Gauteng, South Africa

July 2021

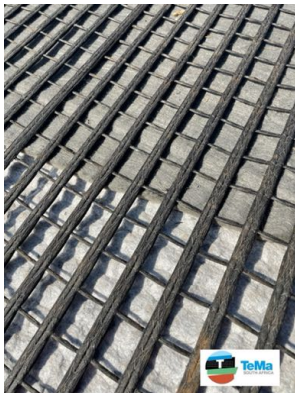
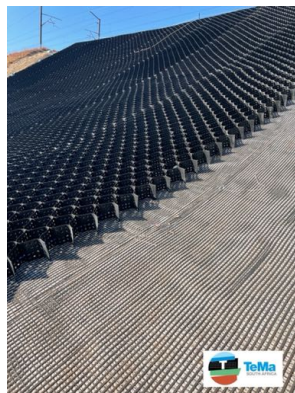
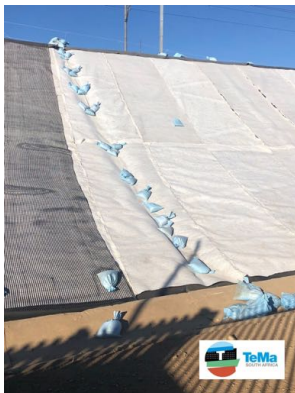
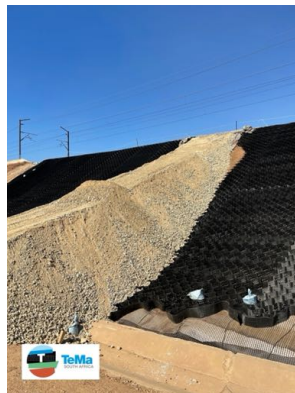
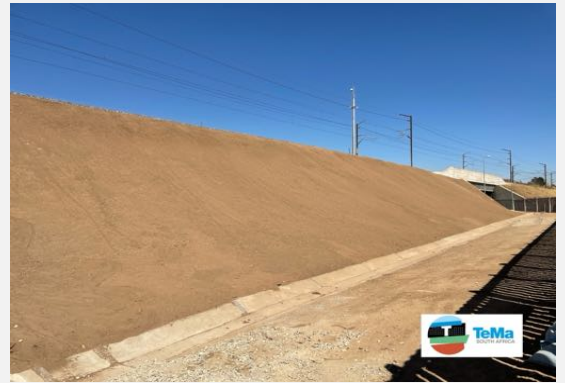
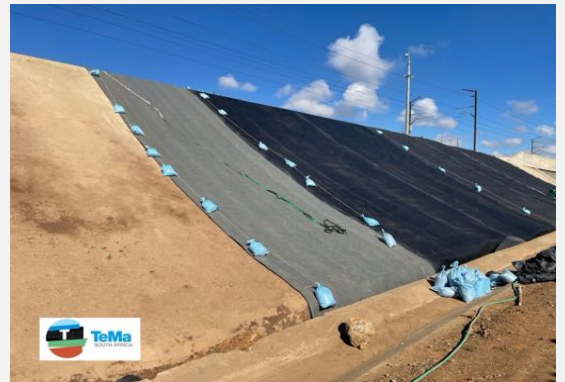
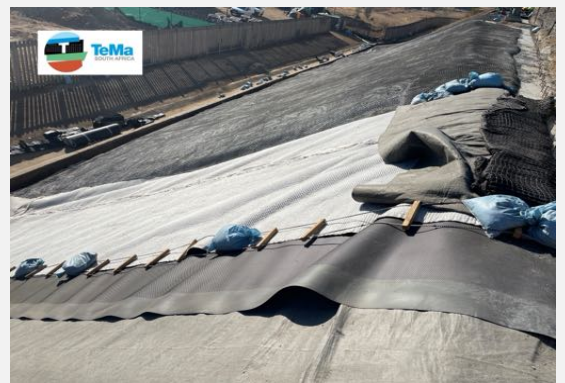
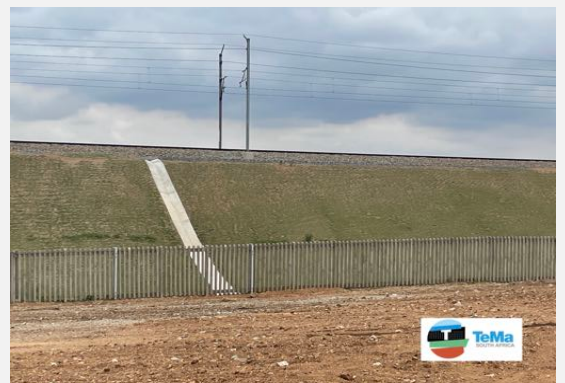
TemaTEX NW10 (100gsm nonwoven geotextile) was installed on the regraded steep side slope as a geomembrane liner protection layer. The **HDD 10 85 12F** (12mm Studded HDPE drainage core with boned geotextile) geocomposite was then placed above the geomembrane liner to collect new rainwater volumes and drain them away from the structure and prevent further ingress into the embankment.

Finally the **TeMa-CELL HD20B-200** (200mm high, HDPE Geocells) were placed along the area. This was underlain by the **X-GRID PET-PVC-0 200/20** in order to provide veneer reinforcement stability to the layer down the steep side slopes.

Lastly the cells were filled with topsoil and grassed and stormwater control structures fitted.
